ARNAULT BRANCH MINE DAM  
WASHINGTON COUNTY, MISSOURI  
MO 30716

# PHASE 1 INSPECTION REPORT NATIONAL DAM SAFETY INSPECTION

# ARNAULT BRANCH MINE DAM

Arnauld Branch Mine Dam (MO 30716),  
Mississippi - Kaskaskia - St. Louis Basin.  
Washington County, Missouri. Phase I  
Inspection Report.

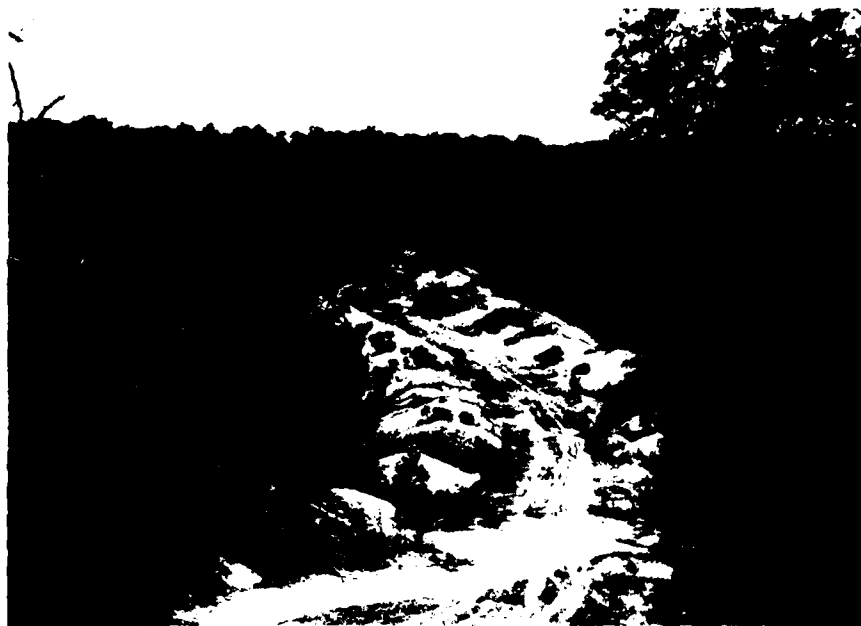
1. View along crest from east abutment.

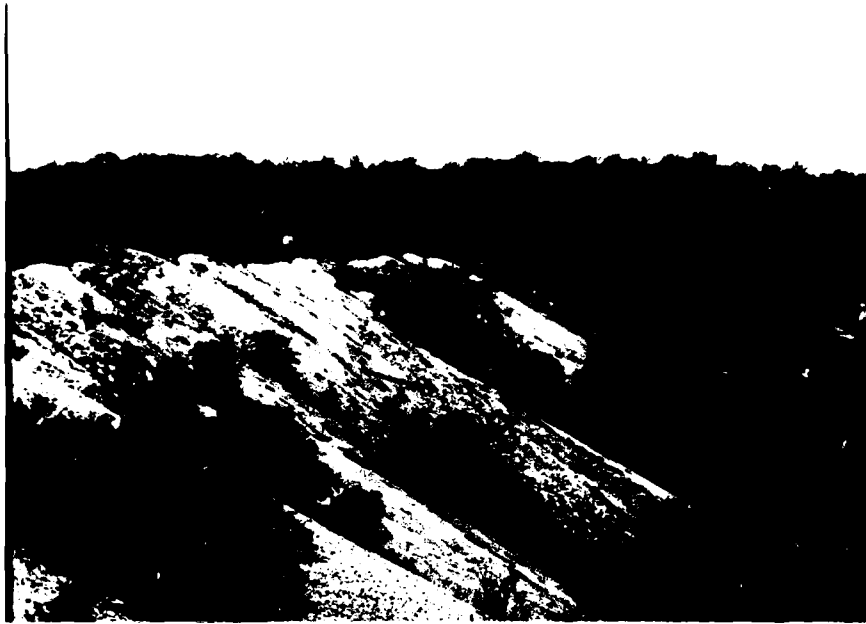
The vertical and horizontal alignment of the dam crest do not appear to be disturbed by deformation. No evidence of detrimental settlement, depressions, cracking or animal burrows were found during the inspection. It must be emphasized, however, that in the general vicinity of the maximum section on this dam, the surface of the dam was unusually uneven possibly due to lax construction control, as compared to most tailings dams in this area. This resulted in a very irregular downstream slope where possible post-construction deformations would be very difficult to detect (Photo 3; Appendix A).

3. Downstream slope from east abutment. Unevenness due to uncontrolled construction. (See Section 3.1.b)
